Concrete Paths

Concrete Results

Dam West Subdivision

Peoria Street and Yale Avenue
Aurora, CO

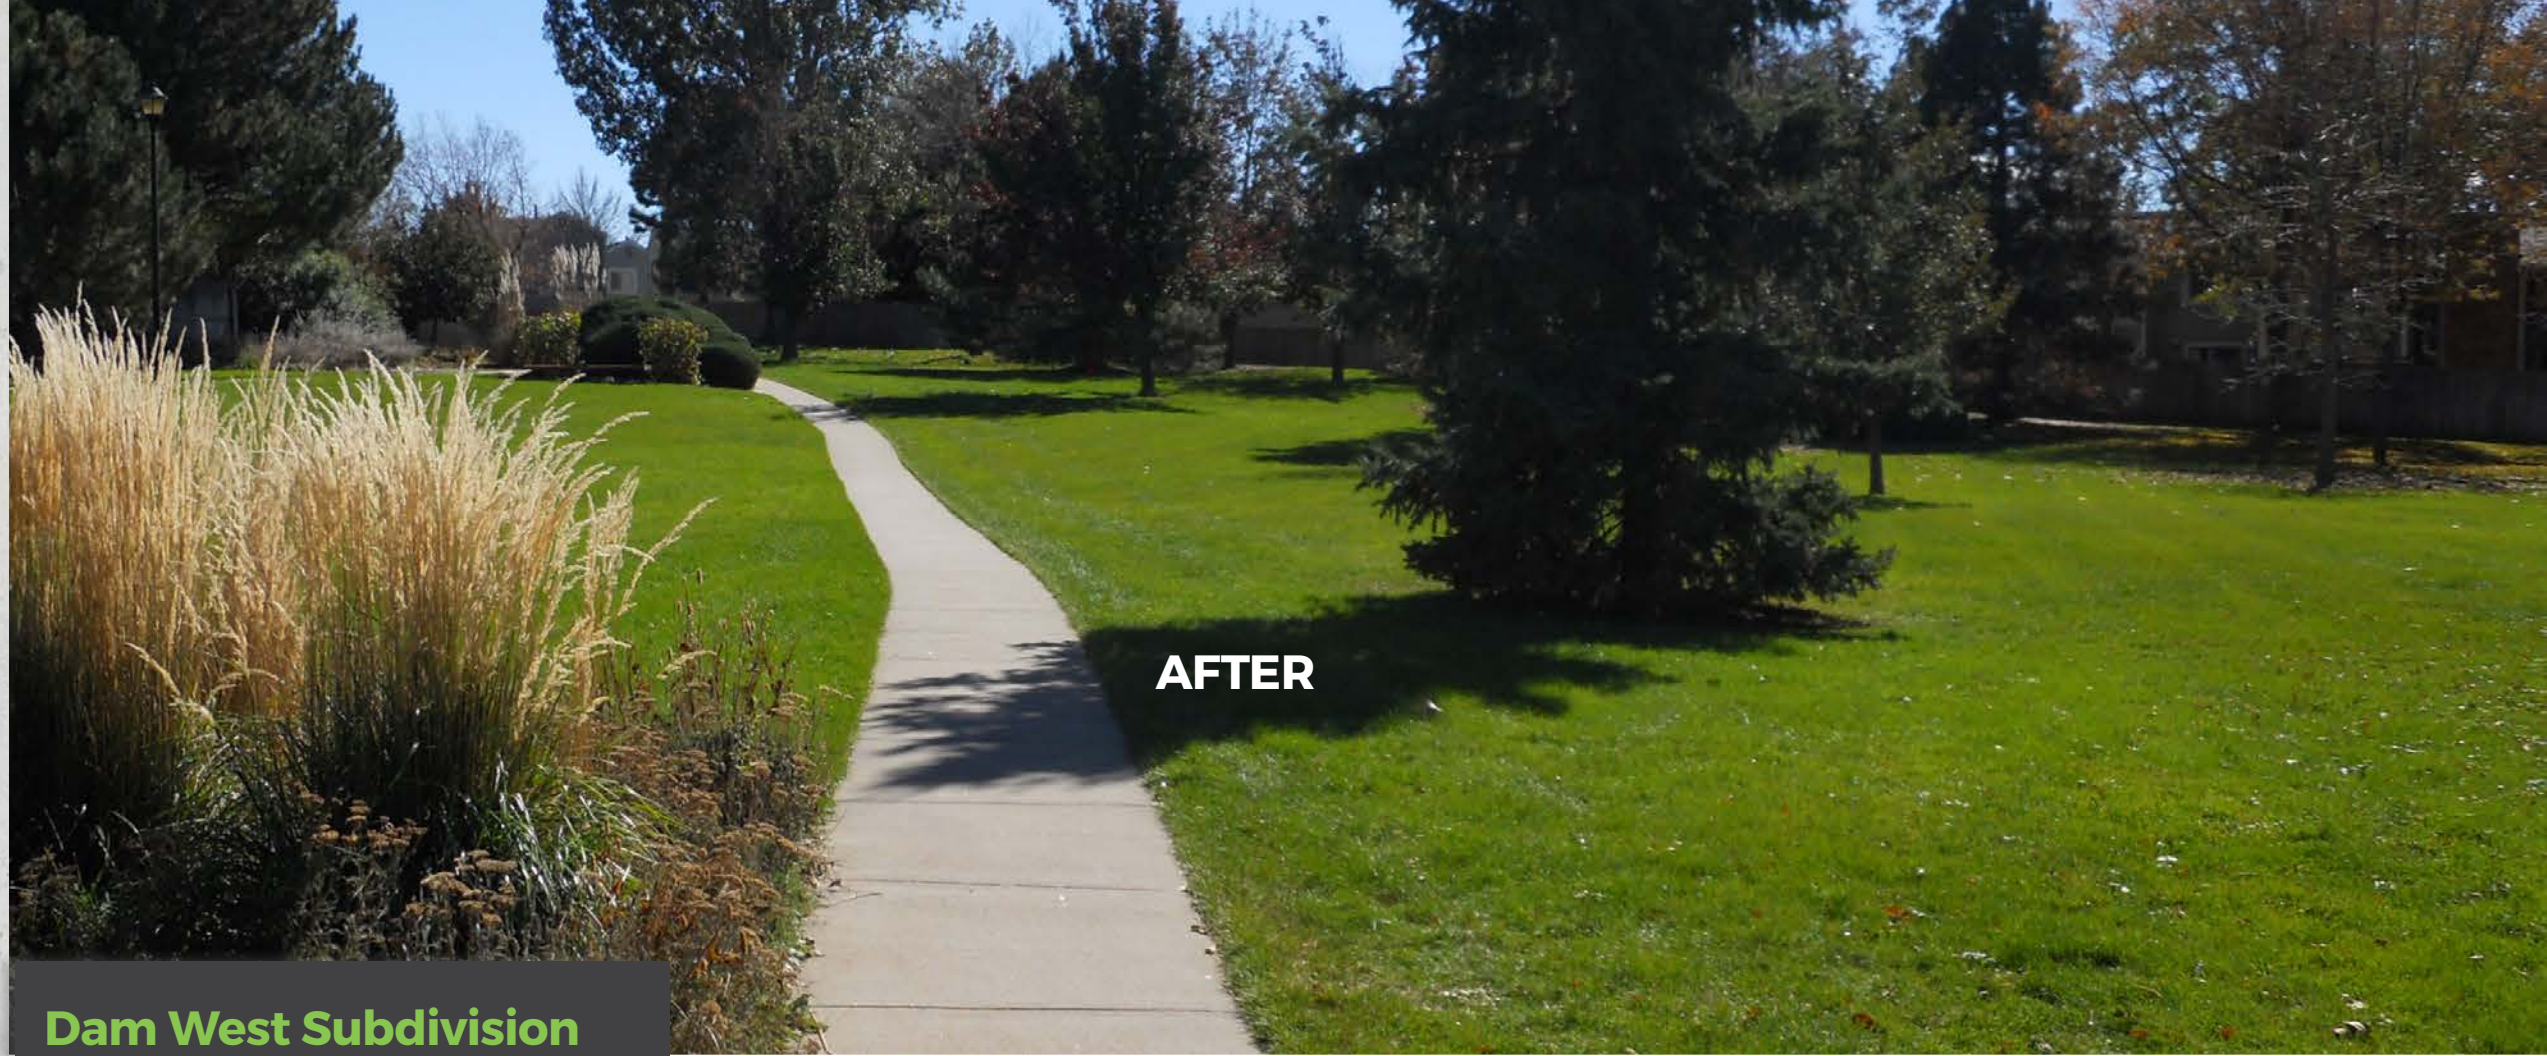
AFTER

- 10,500 feet in length, 4 - 5 feet width
- 4 inch thick unreinforced concrete
- Placed on compacted subgrade following removal of existing asphalt pavement

- 4,000 psi concrete
- Fixed form placement with wood screed.
- 4 feet O.C. joint spacing

The paths were literally falling apart, shrinking in width, and in some places, completely disintegrating. After considering the life cycle costs of replacing the path system with concrete or asphalt, the board elected to systematically replace all the asphalt paths with concrete pavement. The project was phased over eight years, to accommodate budget constraints.

The project was completed in 1999. Total cost of the reconstruction was \$105,000. Other than replacing a panel or two due to tree root expansion, the HOA has spent no money on maintaining the concrete path system over the last 25 years, freeing up resources to spend in other areas. Besides the concrete path system, residents also enjoy their concrete parking lot and post-tensioned concrete tennis courts.
