Concrete Results

Concrete Overlays

Pikes Peak Shuttle Lot Denver International Airport

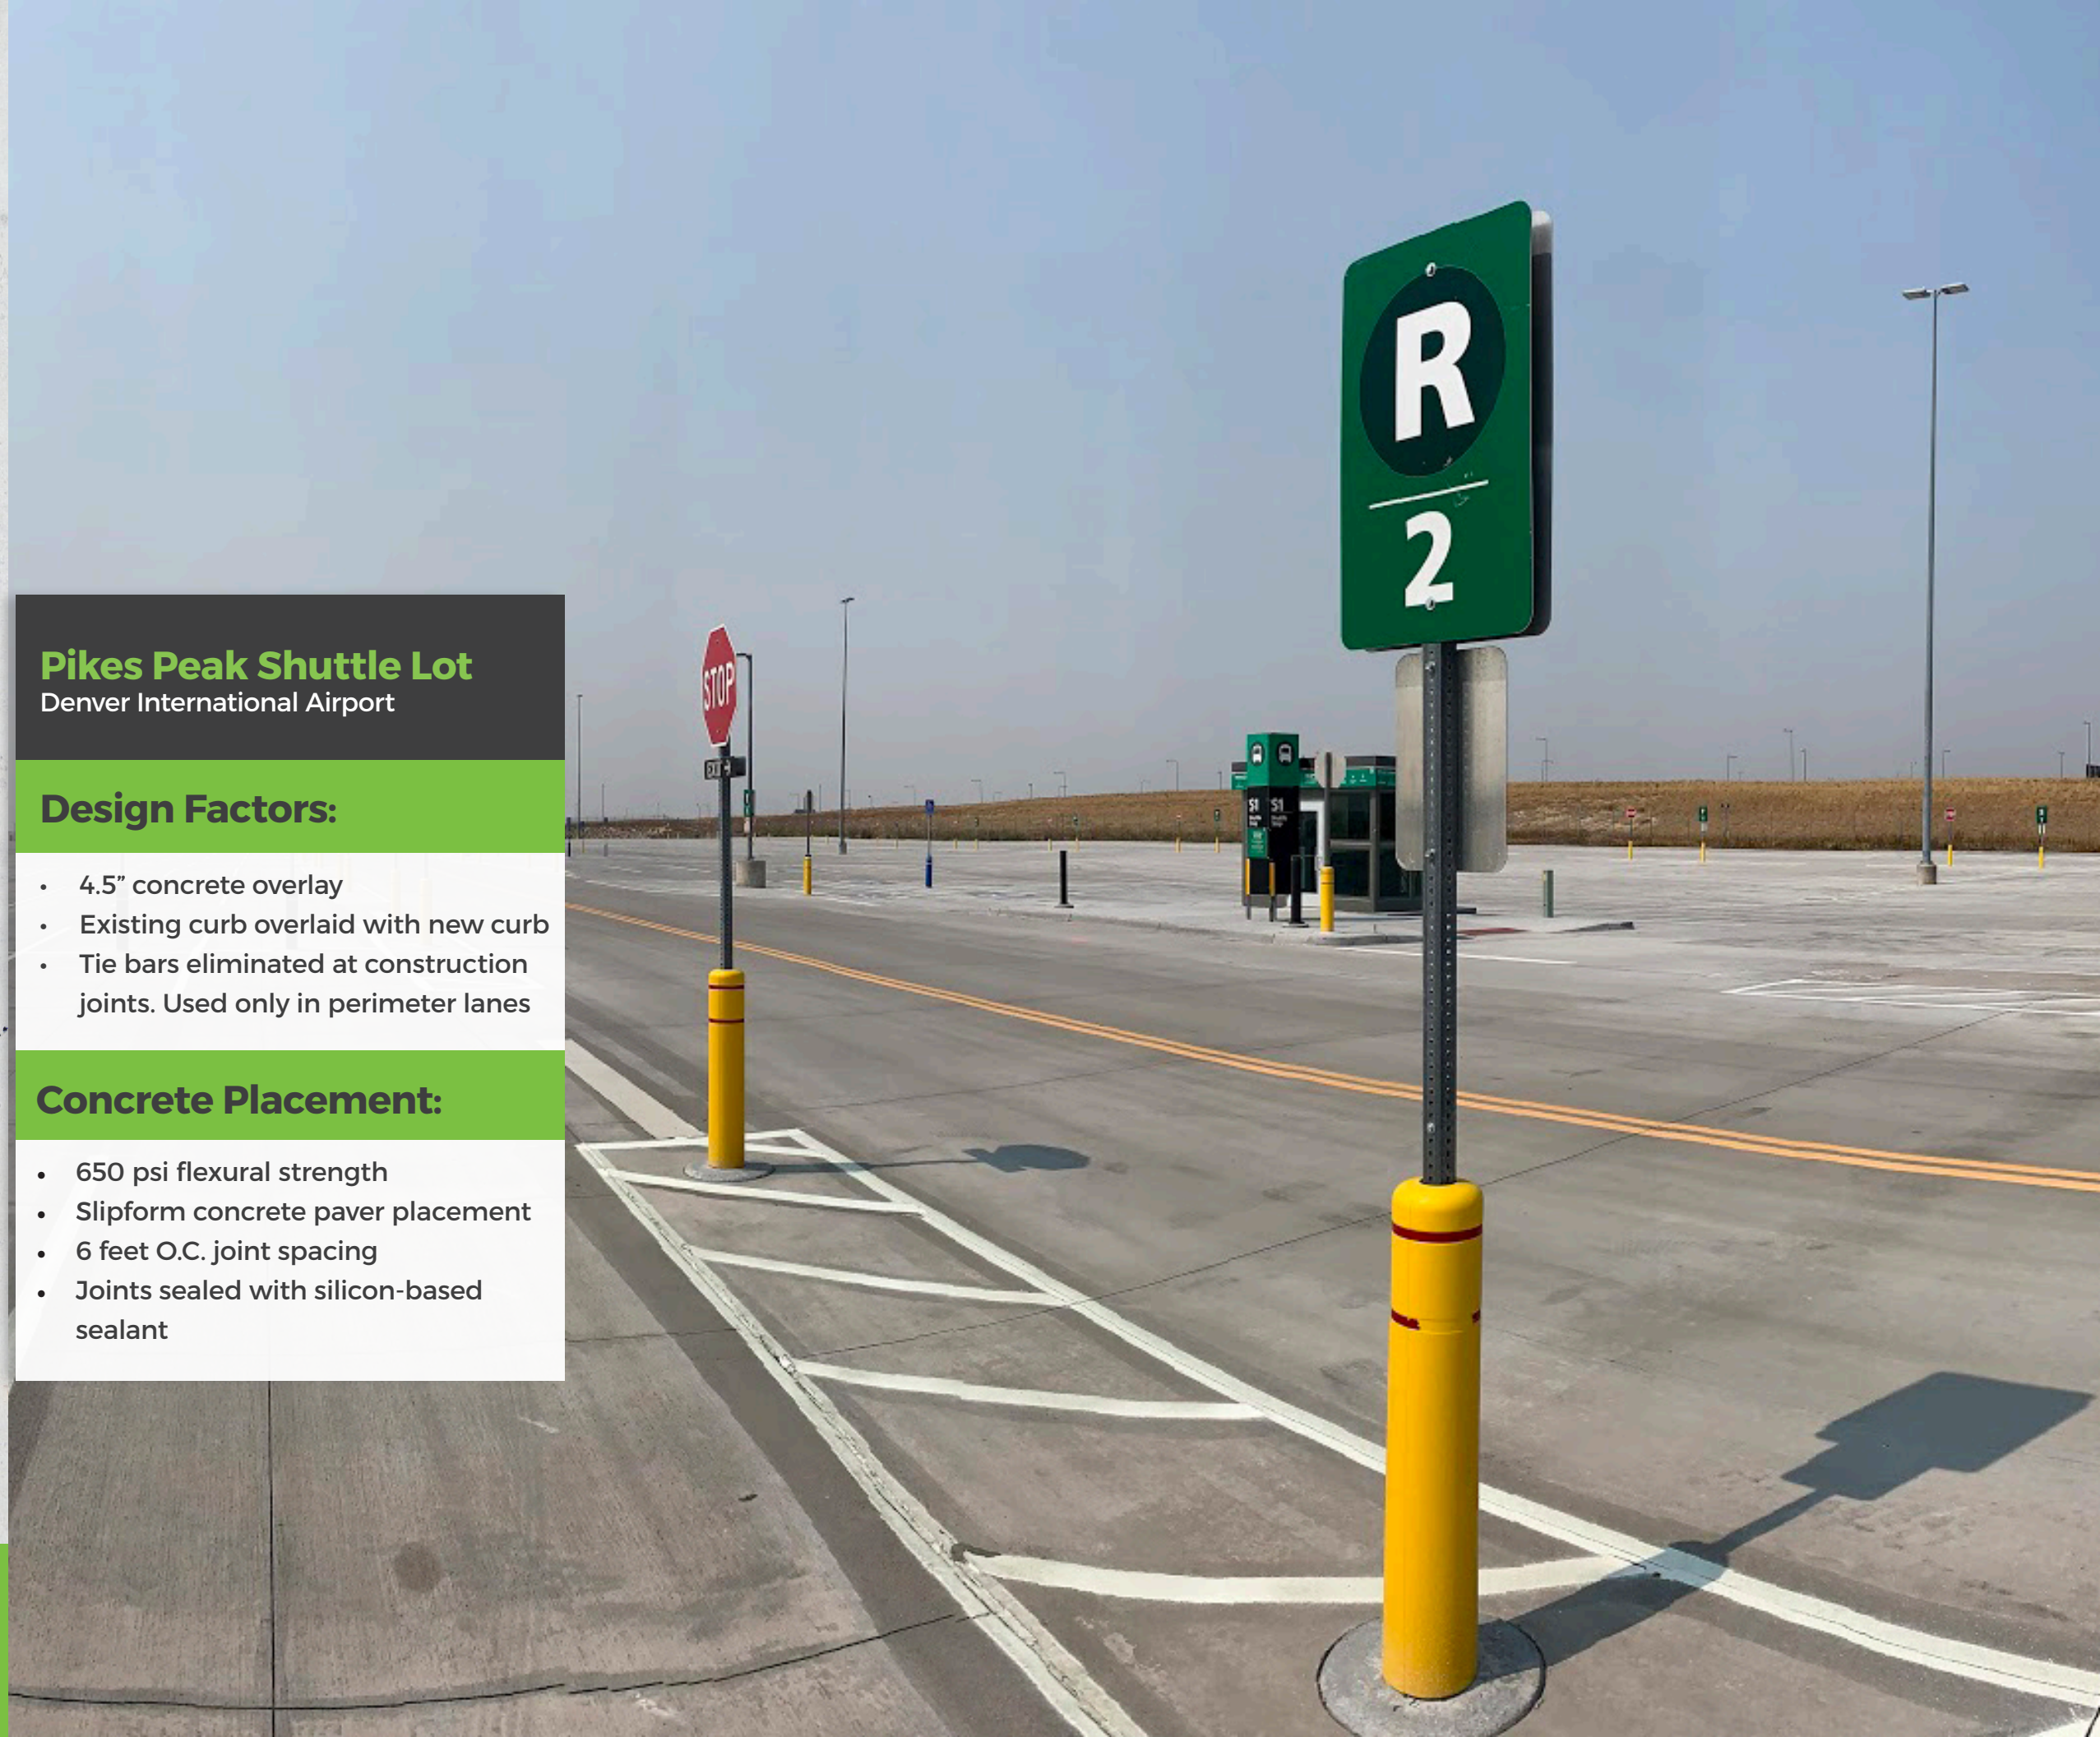
- 4.5" concrete overlay
- Existing curb overlaid with new curb
- Tie bars eliminated at construction joints. Used only in perimeter lanes

- 650 psi flexural strength
- Slipform concrete paver placement
- 6 feet O.C. joint spacing
- Joints sealed with silicon-based sealant
